# **An Analysis of Possible Microbiologically Influenced Crevice Corrosion of 316 Stainless Steel in a Seawater Environment**

MASTER OF SCIENCE IN OCEANOGRAPHIC ENGINEERING

MASSACHUSETTS INSTITUTE OF TECHNOLOGY

WOODS HOLE OCEANOGRAPHIC INSTITUTION

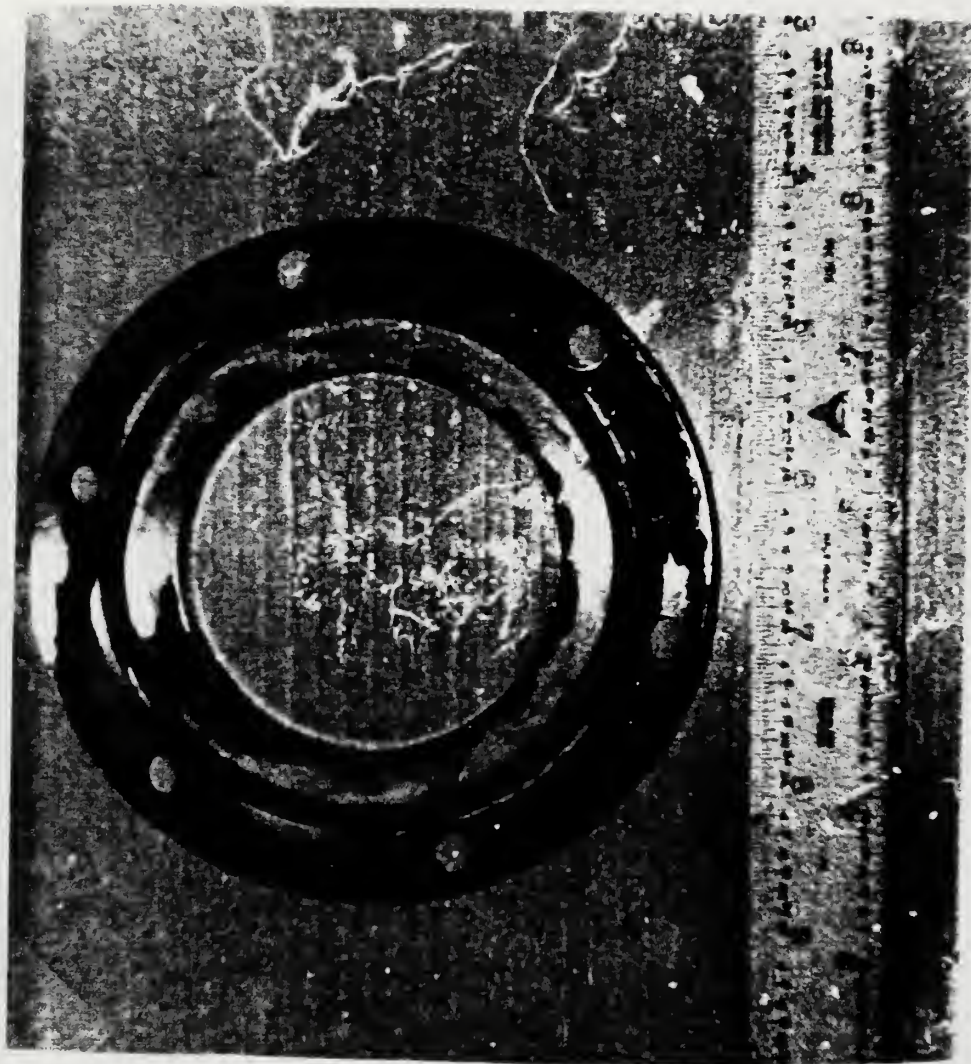
Figure 1-1: Corrosion-Damaged Specimen #1 (O-ring grooved side)

experiment which exhibited this rapid and severe crevice corrosion. These components were 316 Stainless Steel space rings which were used to join two pressure housings on a large fixed instrument. The components were produced on an end-mill in the machine shop at the Woods Hole Oceanographic Institution and given a smooth surface finish. Each has six holes through which fasteners passed and an O-ring groove milled into one side. Outer diameter is 4.5 inches, inner diameter is 3.5 inches, and thickness is 3/8 inches. Figures 1-1 and 1-2 are photographs of one of these corrosion-damaged components, while figure 1-3 is a line drawing of the vorticity instrument suspended within its tripodal frame for deployment on the sea bottom. The location of the two rings in the pressure housing is indicated by the arrow. The rings were separated from the rest of the instrument by spacers composed of Delren plastic.

The particular components which were analyzed by me were utilized in an instrument deployed on 11 July 1994 at 48° 23.55' N latitude 124° 31.91' W longitude in 130 meters of water off the coast of the state of Washington. Surface tidal currents were approximately 3 knots. A sacrificial zinc was attached in the immediate vicinity of the spacer rings. When the instrument was recovered on 28 May 1995, it was immediately noted that the zinc had been totally consumed. Upon disassembly, the severe corrosion (see figs. 1-1 and 1-2) of the rings was noted, as well as the fact that they were both heavily coated with a brown slime. At the time, it was assessed that if the corrosion had proceeded much further, the pressure boundary would have been breeched, the experiment flooded out, and its data lost.

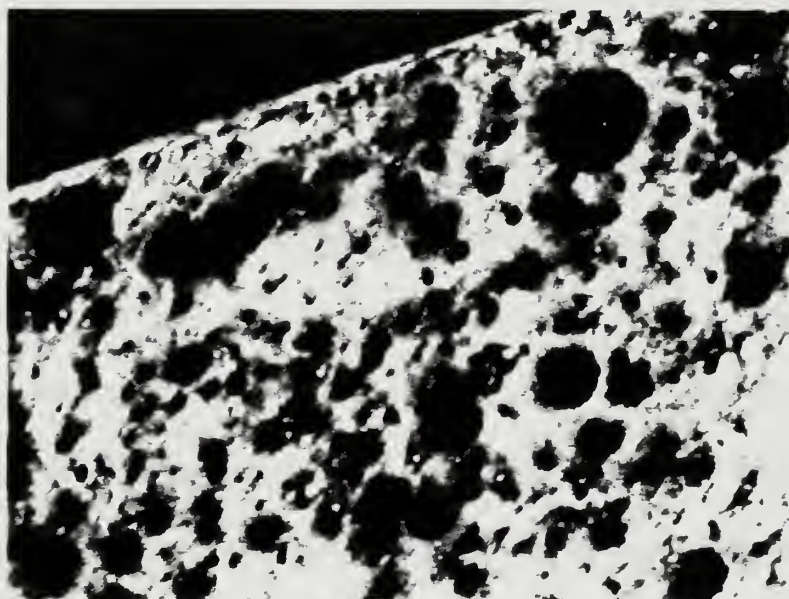
Figure 4-14 Specimen #2 Deep Pits (100X magnification)

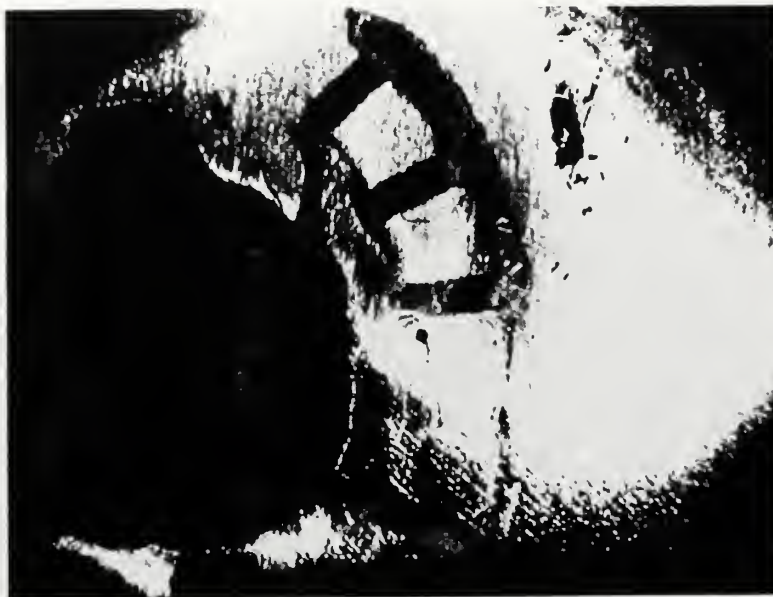
Figure 5-3: Active Seawater Specimen (20X magnification)

active specimen. It did display the formation of a single pit at the edge of the crevice region, suggesting that with additional time, more significant corrosion might have occurred.
